Tail Rotor Spindle Installation

Safari Service Bulletin

Date: May 12, 2006 To: All Safari and Baby Belle Owners

Subject: Tail Rotor Spindle Orientation Compliance Time: Before Next Flight

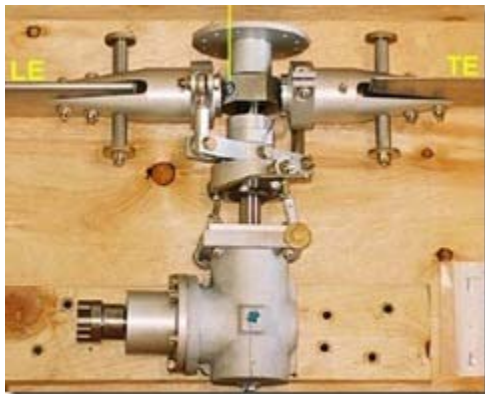
It is possible to install the tail rotor spindle with the delta hinge 90 degrees out of correct orientation. While the blades and pitch change mechanism will operate correctly, there will be increased vibration and a high potential for failure.

The tail rotor assembly should be inspected to verify that the spindle is correctly oriented as shown in the accompanying picture. The delta pin should be oriented towards the rod ends on the tail rotor pitch arm which is also towards the leading edge (LE) of the blades. In the event that the spindle has been installed backwards (ie. delta pin towards the trailing edge (TE) of the blades), the helicopter should be immediately grounded and the owner should contact the factory for assistance before operating the helicopter.

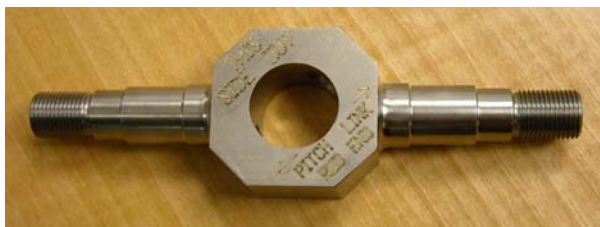
Note: All tail rotor spindles are now clearly marked for correct installation as shown above.
