## CRITICAL NOTICE – TAIL ROTOR BALANCING

February 29, 2012

### IMPROPERLY PLACED WASHERS ON GRIP

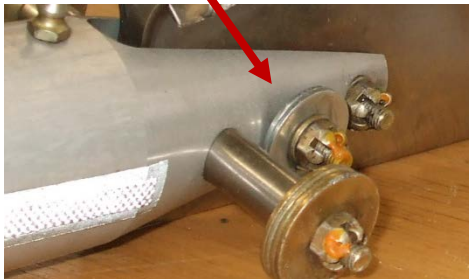
The photo above left shows a tail rotor grip with additional weight added to the tail rotor grip using the tail rotor grip bolts. Under no circumstances should the tail rotor be balanced in this way. Addition of weight to the tail rotor grip increases the centrifugal load on the tail rotor head bearings and increases the amount of stress on the tail rotor spindle.

If you have been operating your SAFARI with weight improperly installed on the tail rotor grips as shown above, please contact the factory before flying your helicopter again.

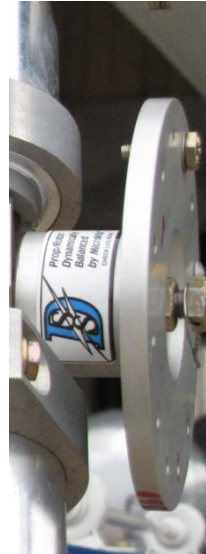
### TAIL ROTOR BUMP BALANCE

The bump balance (shown on the right) installed on the tail rotor provides a safe and effective location for weight needed to properly balance the tail rotor of the SAFARI. If the tail rotor cannot be balanced using weight installed on the bump balance, there is a serious underlying issue causing a dynamic out-of-balance condition which must be addressed. The photo above right shows the correct use of the bump balance to add weight.
