February 2, 2013

NOTICE TO ALL SAFARI OWNERS REGARDING SECURE ATTACHMENT OF BALLAST IN TAILBOOM

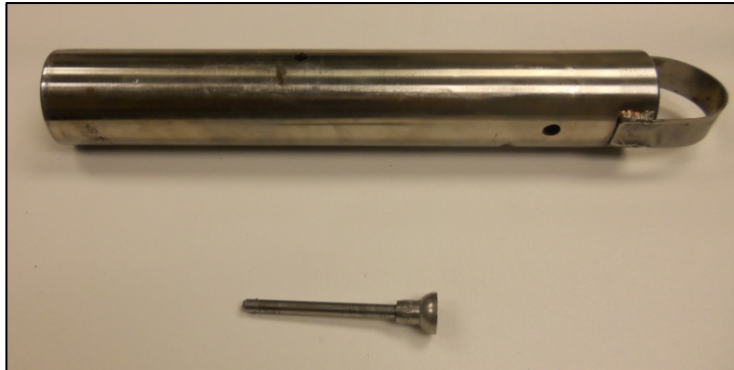
It is critical that the ballast be positively secured when placed in the carrier in the tail boom. The current Safari Kit supplies a Quick Lock Pin which is adequate to secure the ballast if it and the carrier are in good working order.

The pin should remain in place if the release mechanism is not actuated. The size of the pin hole in the carrier should be such that the retaining mechanism can function correctly. Please examine whatever method is in use on your helicopter to be certain it is functioning properly, and that there is no possibility of the ballast being free to vibrate out of the carrier.

The method of attaching the ballast to the tail boom is effective, but it must be carefully verified as part of every pre-flight inspection. To this end, the Safari Flight Manual (POH) has been updated to include a check of the ballast for security during pre-flight checks.
