SAFETY NOTICE SN024

TaperLock Bushing/Hub Set Screws

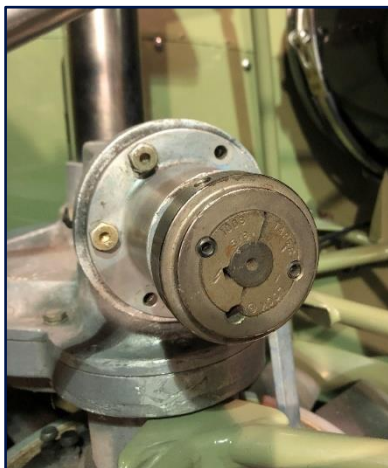
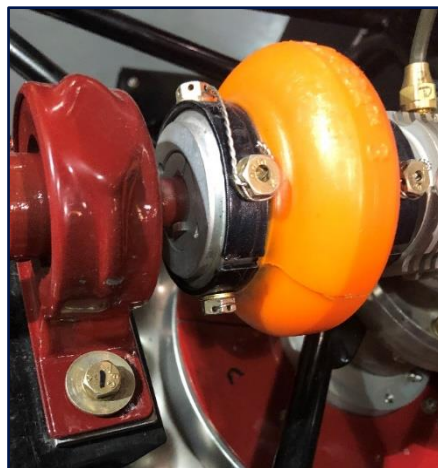
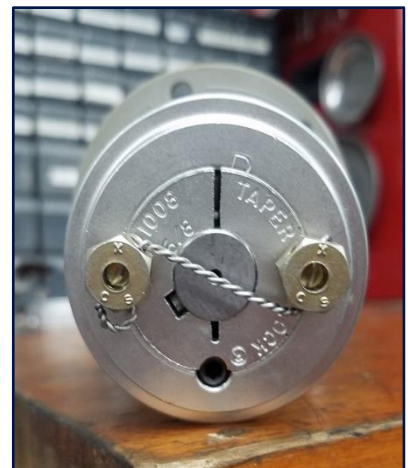
The set screws are out of sight inside the orange flex coupling when installed, making frequent inspection impractical.

Even when secured with LocTite, the set screws can back out as the glue degrades over time. When the set screws allow the inner hub to loosen, it is subject to vibration and will likely break. Depending on which coupling fails, this will either break the connection between the flex coupling and the output shaft or the tail rotor driveshaft.

Either event will be extremely dangerous in flight, with a loss of tail rotor authority at the very least.

The set screws installed in the TaperLock hub and bushing on the transmission output and provided with the Tail Rotor Driveshaft Kit should be replaced with AN74-A4 drilled head bolts and secured with safety wire.

Please either secure these bolts from your usual supplier or contact the factory. We strongly suggest you add the inspection of these bolts to your annual condition inspection as well.
