SAFETY NOTICE SN026

DEFECTIVE CHIP DETECTORS

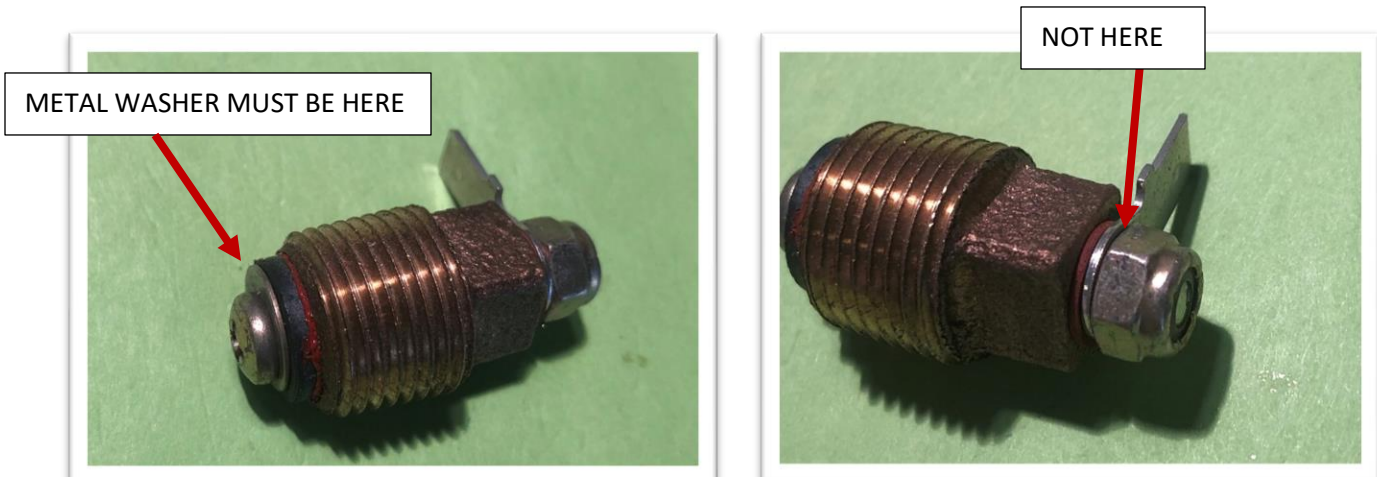
We have become aware that we have shipped chip detectors that are not correctly assembled. While they will test positive for current, they are assembled with a washer in the wrong position. This arrangement of the component requires far more metal to accumulate before it bridges across to send a signal to the chip detector light.

The chip detector should require very little metal to accumulate before sending the alarm to the chip detector light.

Please examine the detectors you have, either on your helicopter or still in the box. Photos below show the correct assembly. The difference is minor, but extremely important.

If yours are assembled incorrectly, either re-assemble them yourself to match the photos below or contact us for replacement.
