## Horizontal Stabilizer Inspection

Models affected: Helicoms, Commuters, BABY BELLE and SAFARI helicopters.  
Mandatory: Detailed Inspection for all models if a tailrotor strike or incident has occurred.

Reason: To detect cracking and prevent possible inflight failure of Horizontal Stabilizer.

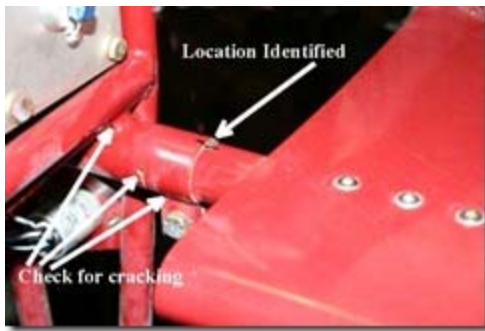
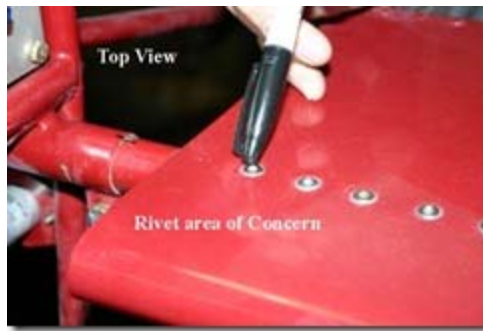
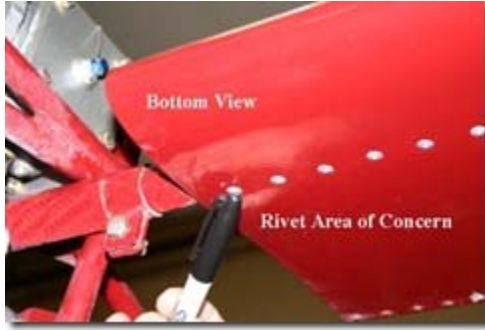
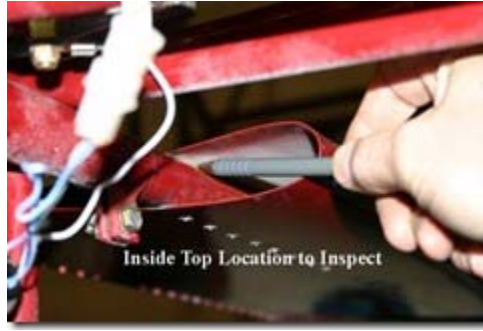
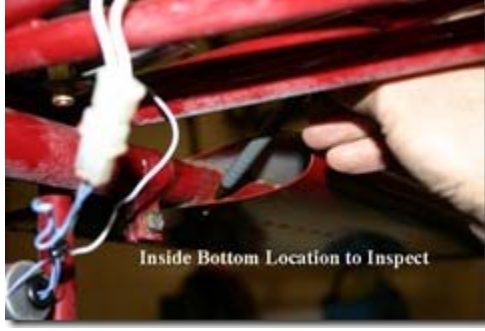
**Click Any Image to open larger version:**

Inspect for corrosion and cracking in the areas shown. The origin of the cracking is expected to come from the rivet holes drilled into the stabilizer tube for securing the aluminum skin. It is expected that this cracking will propagate from the top hole down the side of the tubing or from the bottom hole up the side of the tubing. Both directions should easily be seen when viewing the area of concern from the airfoil end nearest the mounting bracket (tailrotor gearbox). Any loose rivets found during this inspection should be replaced and logged. Those of you have went the extra step for perfection and capped both ends of the horizontal stabilizer will have to remove the inboard end cap for your inspection and leave off to allow daily inspection.

Identify location of the current setting for your stabilizer.

Remove the cotter pin, loosen and remove bolt/nut.

Pull out the stabilizer from the support tube housing. As a precaution you should also inspect the support tubing for cracking at the weld locations attaching it to the tailboom.

Completion of this inspection should be logged.
